Annex 10.6.

Monitoring of function of spawning sites of within project ReBorN (LIFE15 NAT/SE/000892)

County Administrative Board of Norrbotten 2020

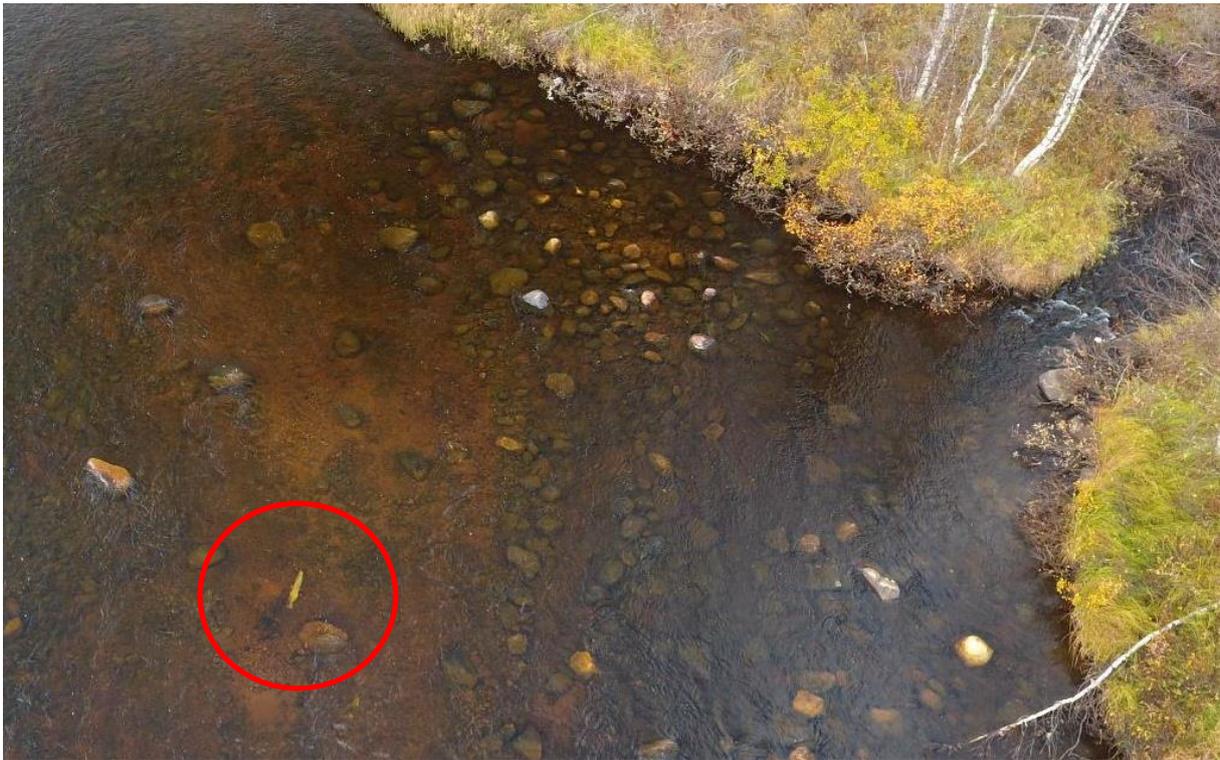
*Figure 1. Spawning salmon at a restored spawning area in river Linaälven 2018.
Photo: Mikael Nilsson, Fiskmiljö Nord AB*

To monitor one of the expected results, that the number of spawning sites (Fig. 1) for Atlantic salmon and brown trout will increase and to ensure that the sites are functional and used by the targeted fish species we have monitored a sample of created spawning sites within the project.

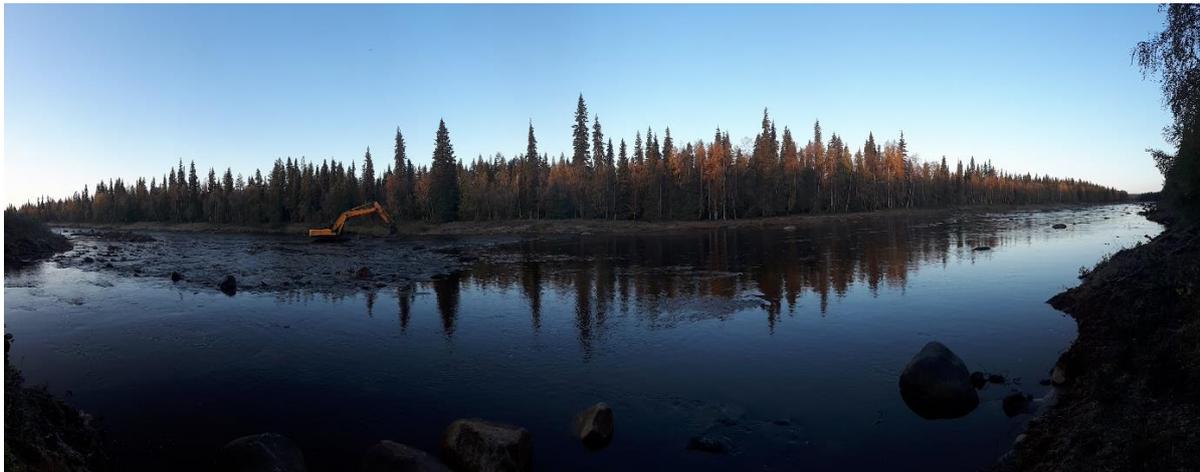
Figure 2. A large spawning area (~ 2000 m²) at Snasko in river Råneälven. It stretches from the river neck and 200 meters upstream. Photo: Andreas Broman, CABN

One of the objectives in the ReBorN project was to create 2300 spawning sites (6 m²). By the end of field season 2020 more than 10 000 spawning sites have been created. Smaller areas or single sites are mainly created or restored in small brooks. Larger areas that are made up of many sites are restored in larger rivers like the main channels of the rivers Råne-, Kalix- and Lögdeälven. These spawning areas can be as big as 2000 m² at some places where lots of gravel in the right sizes where found and other conditions where favorable (Fig. 2). The spawning areas are usually located at the top of a rapid (river neck, where calm water pass over into a rapid).

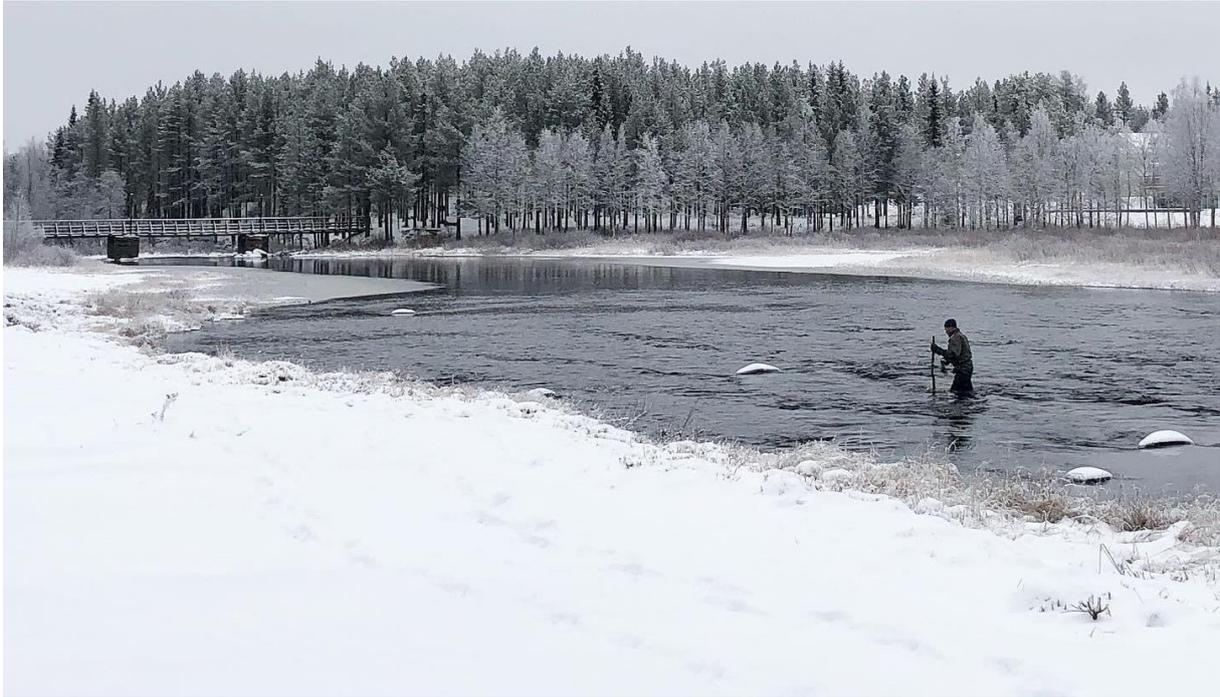
Figure 3. Monitoring of spawning area in river Vassaraälven in October 2020.

The monitoring in 2020 was not complete due to a couple of different factors. In the County of Västerbotten there was very high water levels in the autumn when the monitoring was taken place which made the monitoring difficult and only 14 areas where visited in the mainstem of river Lögdeälven, however 59 areas were visited in river Mjösjöån. In the County of Norrbotten it was snow and cold making the monitoring though, although 31 spawning areas in river Vassaraälven was monitored (Fig. 3). No monitoring where conducted in the other rivers in the County of Norrbotten.
